**BUILDING
MECHANICALS
AND
ENVELOPE NEEDS**

FACILITY ASSESSMENT REPORT SPRINGFIELD PUBLIC SCHOOLS

Springfield, Minnesota

Project #16-18829

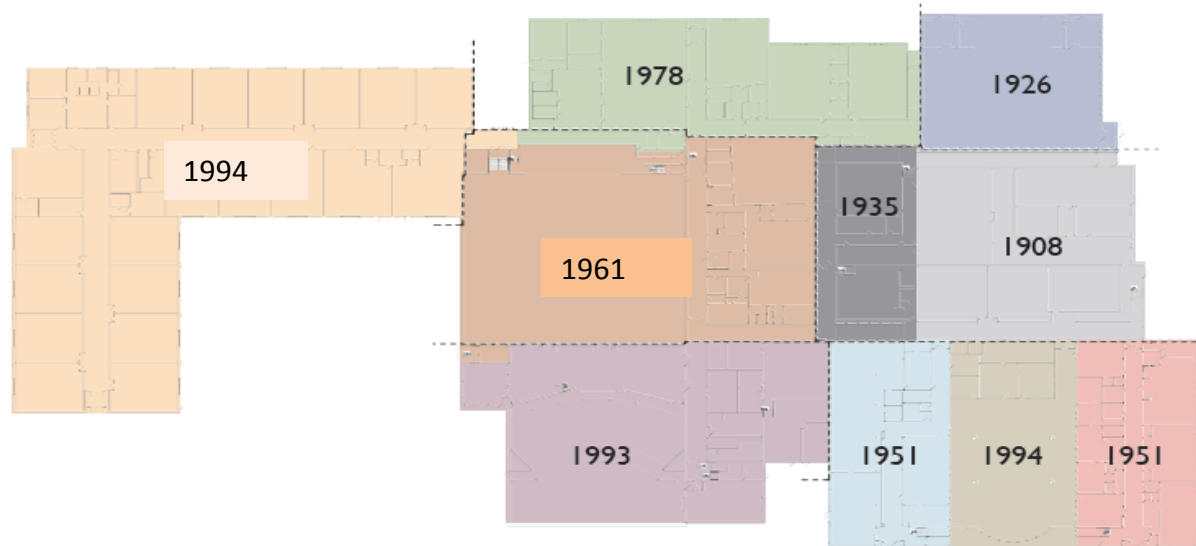
ADDITIONS TO SPRINGFIELD PUBLIC SCHOOLS

Located on two city blocks in a predominantly residential neighborhood, the Springfield Public Schools building was constructed circa 1908 at 12 Burns Avenue in Springfield, Minnesota. With an increase in student enrollment, the facility expanded with multiple additions over the last century. The first addition in 1922 (not shown on map) provided the building with a new larger boiler room. In 1926, the space that is now the Elementary School Gym was added. Other additions in 1935, 1951, 1960, 1963, 1978, 1991, 1993, and 1994 make up the current facility, which totals approximately 168,450 square feet.

First Floor Additions
